## Acoustic levels of heavy truck tire ruptures

Matthew Wood M.S. \*, William Woodruff Ph.D.

InSciTech Inc., 185 Berry St., Suite 3700, San Francisco, CA 94107, USA

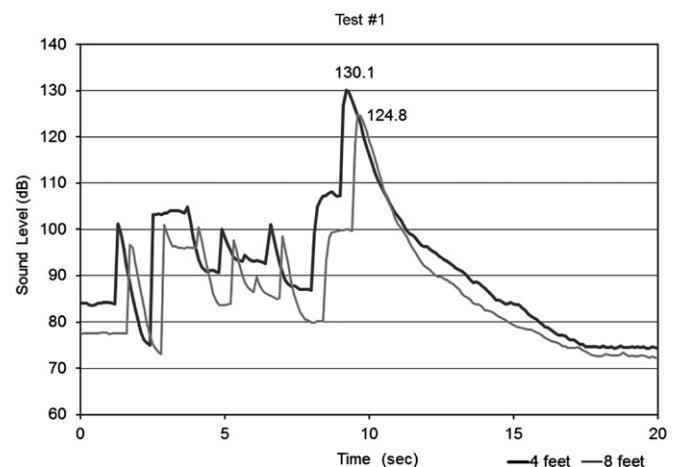
Fig. 3. Sound level plots for Test #1 at measured distances of 4 feet and 8 feet.

The peak acoustic values measured in the first test were 130.1 dB at the distance of 4 feet from the tire and 124.8 dB at 8 feet from the tire. A plot of the measured data from Test #1 is presented in Fig. 3.

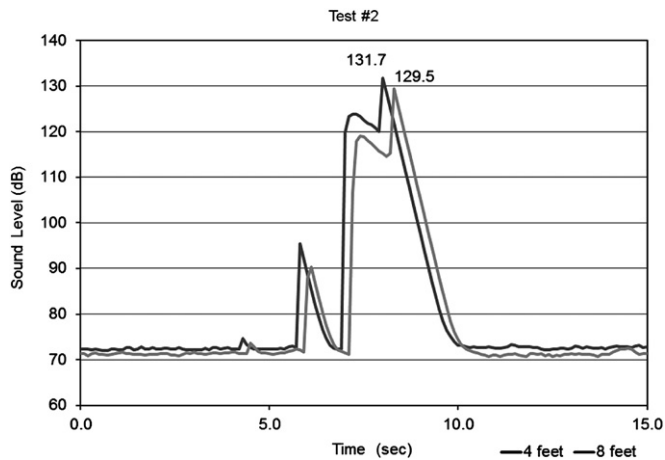
Fig. 4. Sound level plots for Test #2 at measured distances of 4 feet and 8 feet.

The peak values measured in the second test were 131.7 dB at the distance of 4 feet from the tire and 129.5 dB at 8 feet from the tire. A plot of the measured data from Test #2 is presented in Fig. 4.

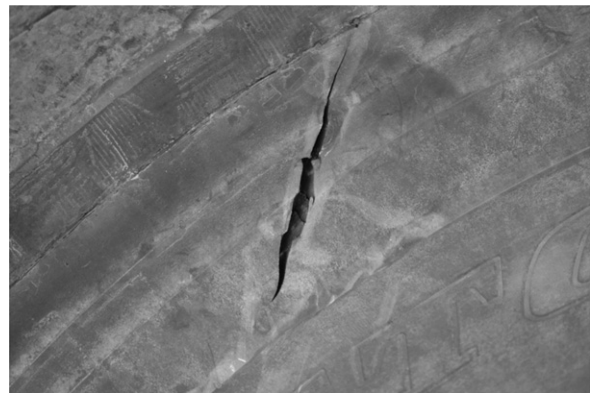
Test #1 Tire – After failure

These test results present a valuable first insight at quantifying the sound energy levels involved with these violent events. In the first test, the impacting blade partially cut into the tire tread which provided more resistance to the cutting force of the blade and resulted in the air pressure being dissipated over a longer period of time than in the second test. During the second test the cutting edge was aligned more with the sidewall of the tire and resulted in a “zipper” type of failure (Appendix B). Frame by frame images from the video recorded during this event are presented in Appendix C. The results of Test #1 demonstrate that the measured readings follow the inverse distance law for sound:
